SUBJECT: LEAD RISK ASSESSMENT AND MOLD
SURVEY FOR HONOLULU HALE

The enclosed subject report, dated February 24, 2012, prepared by Muranaka Environmental Consultants, Inc., has been accomplished and is transmitted for your information and use. This report does not include the Department of the Corporation Counsel which was covered in a separate report.

Photo Log
Honolulu Hale
Lead Paint Risk Assessment and Mold Investigation
MEC Project No.: 2011-0044
July 2011

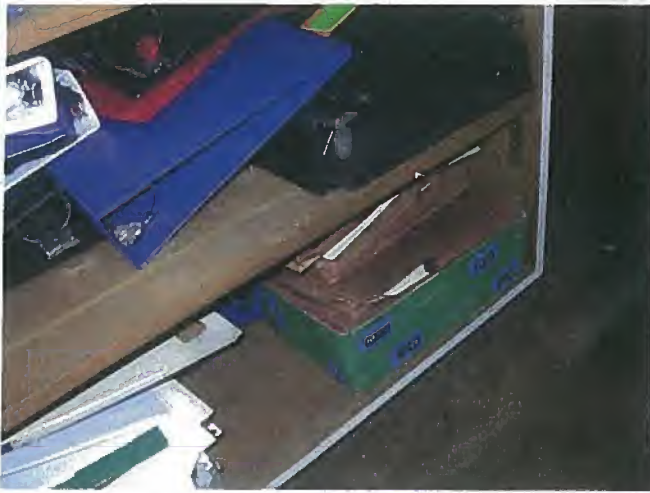
Photo No. 44:
Evidence of mold growth indicated by the gray patches on the binders and wooden shelving, located in the Culture and Arts Office.
